Case History: Cold Storage Chiller-Pan Protection

Case History: Chiller-Pan Protection continued...

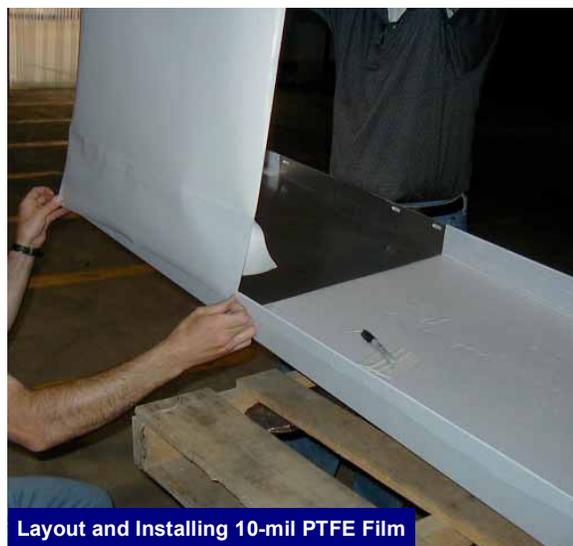
Working with Integument engineers, the customer selected a **FluoroGrip® - P** (PTFE), 10-mil fluoropolymer film which incorporates a proprietary plasma surface activation and acrylic adhesive technology to create a "peel-and-stick" fluoropolymer film. After a simple solvent wipe (isopropyl alcohol) surface preparation, the film was applied to both the interior and exterior pan surfaces -- much like "wallpaper." The project was finished by sealing all film edges with **FluoroGrip® SB-100** brushable fluoroelastomer edge sealant.

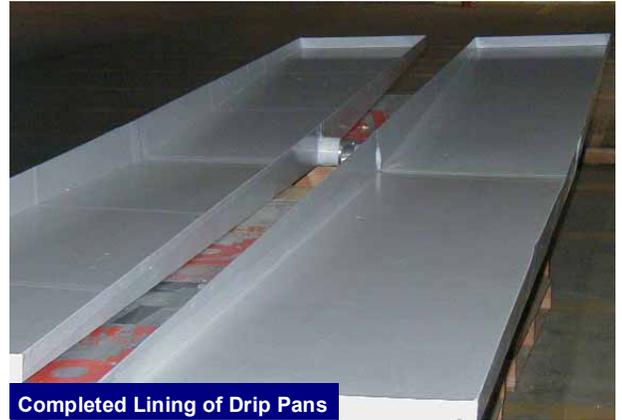
Completed Lining of Drip Pans

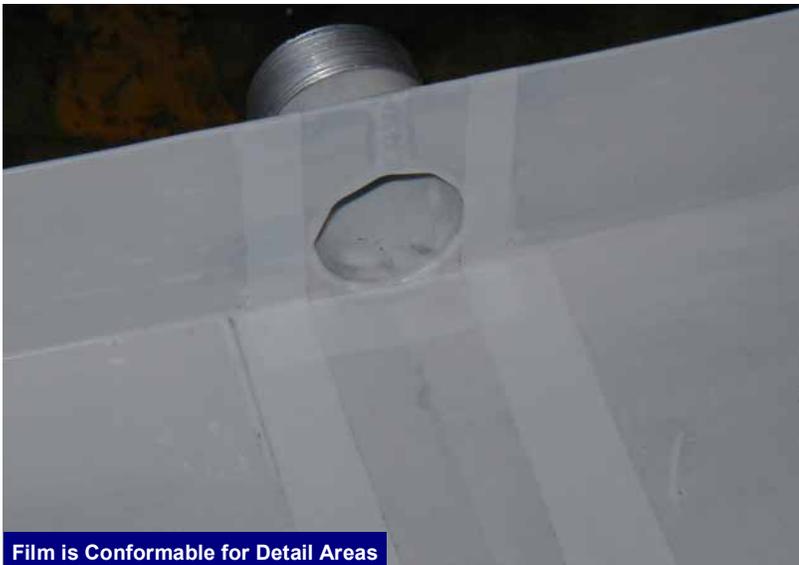
Film is Conformable for Detail Areas
